## Utility of River Training Structures and Present Status in Patuakhali District Bangladesh

Original Research Article

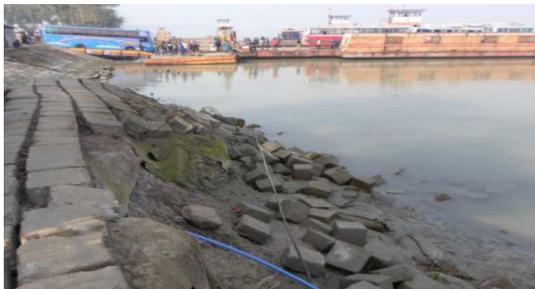
**Fig. 2. Photographic view showed the severe erosion prone area at Lebukhali point of Payra River**

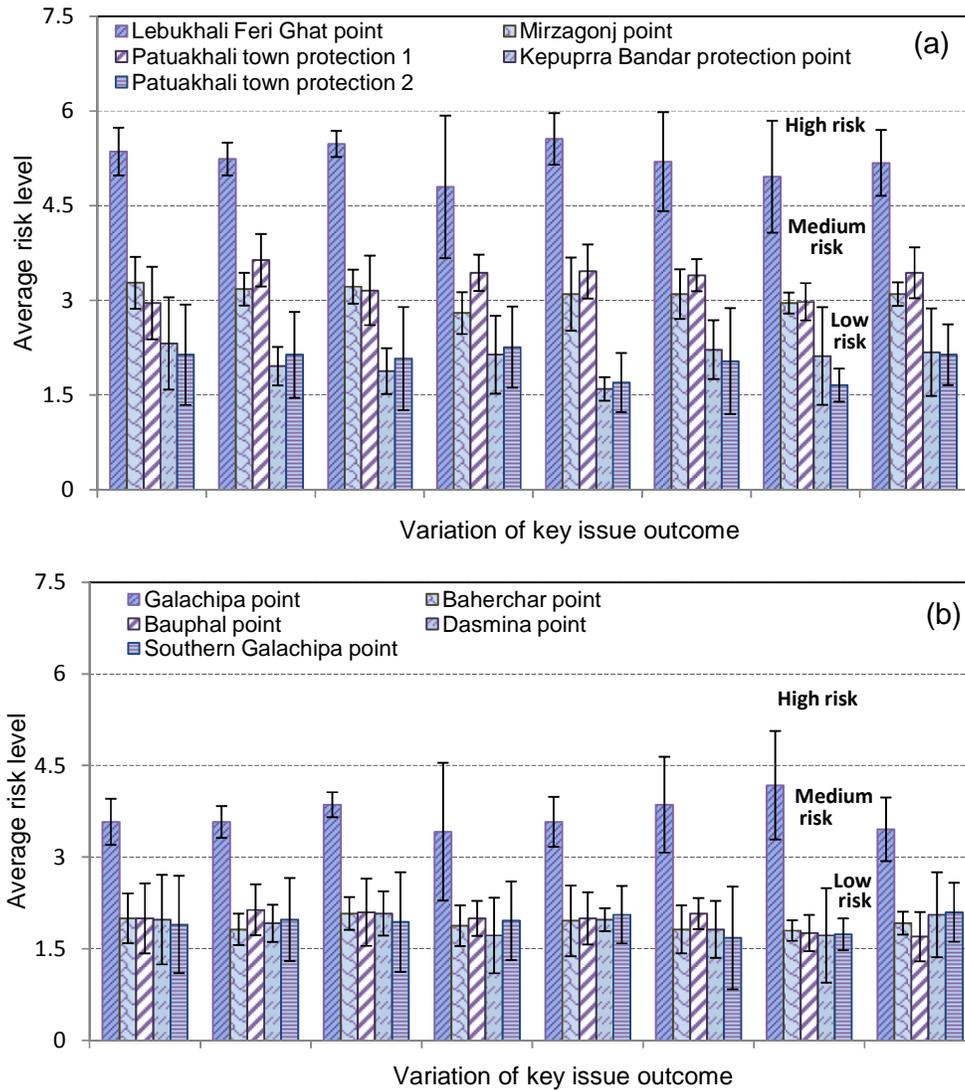
**Fig. 3a and b. Variation of different level of risk in groups at 10 (ten) different location of bank protection practices**

there are three ways river bank generally fail such as: (i) hydraulic forces remove erodible bed or bank material, (ii) geotechnical instabilities result in bank failure, and (iii) a combination of hydraulic and geotechnical forces causes failure [21]. Some river side of this research area are becoming vulnerable condition of erosion due to above mention reason and still these areas are under different level of risk though dissimilar protection measure has been taken. The details of bank erosion and protection measures under different level of risk at different location of main rivers of this study area are described in Table 3. According to the individual's opinion we found different locations at different river side were noticed under different level of risk in which constructed the protection measure. The risk level scores ranged from 1 to 6 with an average of 2.71 represented all the training structures under low to medium level of risk except Payra river side at Lbukhali Feri Ghat point. Adjacent to Lebukhali Feri Ghat and several other points including about 1.74 km concrete block revetment was failed due to high flow velocity directly struck on river bank and return flow creates local scouring near bank which caused massive failure as view in photographic Fig. 2 and represented under high level of risk averages 5.22 as shown in Fig. 3a. The high velocity return current reflects by emerging char at opposite bank of Payra river. For that reason, generation of high expulsion around the revetment also causes of failure. The both bank side of Payra River at Lebukhali Feri-Ghat point is more vulnerable as comparing from others points. Cement concrete (CC) block revetment possess this area safe from tidal current temporarily. The revetment with cement concrete (CC) block including around 1.8 km bank protection work from erosion due to moderate velocity tidal current under low risk level at Patuakhali town protection point 2 and Khepupara Bandar & town protection point. Revetments with geo or sand-cement bag at Lawkati river bank side for Patuakhali town protection point 1 are the defensive structure and relaying under medium level of risk. In this section of the river flowing straight and this protection measure can save the bank from straight flow current. The main purpose of these structures was to modify the struck flow velocity on the river bank and protect from erosion. The earthen embankment used as river bank protection structure of Baherchar point, Bauphal point, Dashmina point and Southern Galachipa point was found under low risk level whereas bank protection by bandals at Galachipa point

was found under medium level of risk as shown in Fig. 3a and b. Therefore, although the maximum bank protection structures condition under low to medium risk level however, all are effective in purposes as several researchers evaluated using different techniques. Sarker and Akter [22] evaluated bank protection structure of Jamuna river and stated as effective, minor damage, major damage, minor damage but effective etc. by historical data and experience from several case studies. Revetment with Jute Geotextile was found as effective after three times investigation of river bank protection measure [23].

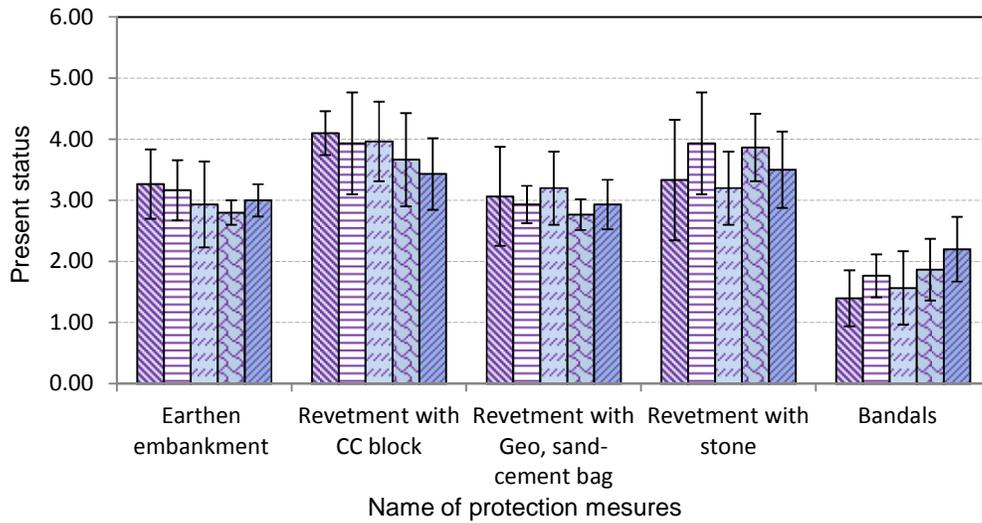
**Fig. 4. Present status of protection measures found at different location based on stable = >4.0-5.0, moderate stable = >3.0-4.0, stable due to maintenance = >2.0-3.0 and short time stable = 1.0-2.0)**

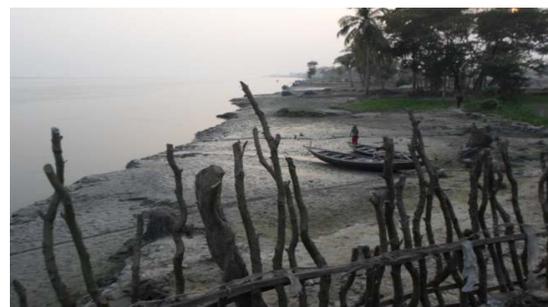
perception, the Bandalling (made by wood) savings temporarily their valuable agricultural land form erosion at Kajal river side, Galachipa. This structure is a simple alternative low cost conventional structure made by bamboo or wood. Bandal structures are physically considered as combined structures of permeable spur dykes and pile dykes [26]. The bandalls are positioned at an angle with main flow. When surface flow forced on the face of structure, it reduced velocity due to obstacle and flow through the bottom direction [28]. These are the characteristics of this structure are for the control velocity of water and sediment flow [29]. Thus, sand bar or char

land were formed along the river bank side due to sedimentation as shown in Fig. 5. However, the structures are required to keep under continuous observation and renovation timely necessarily in any situation.

**Fig. 5. Photographic view of bandaling structure used for controlling bank erosion at Kajal river side in Galacipa**
